TRANSPORTATION SAFETY

REFLEXIONS

Issue 17 – Winter 2001

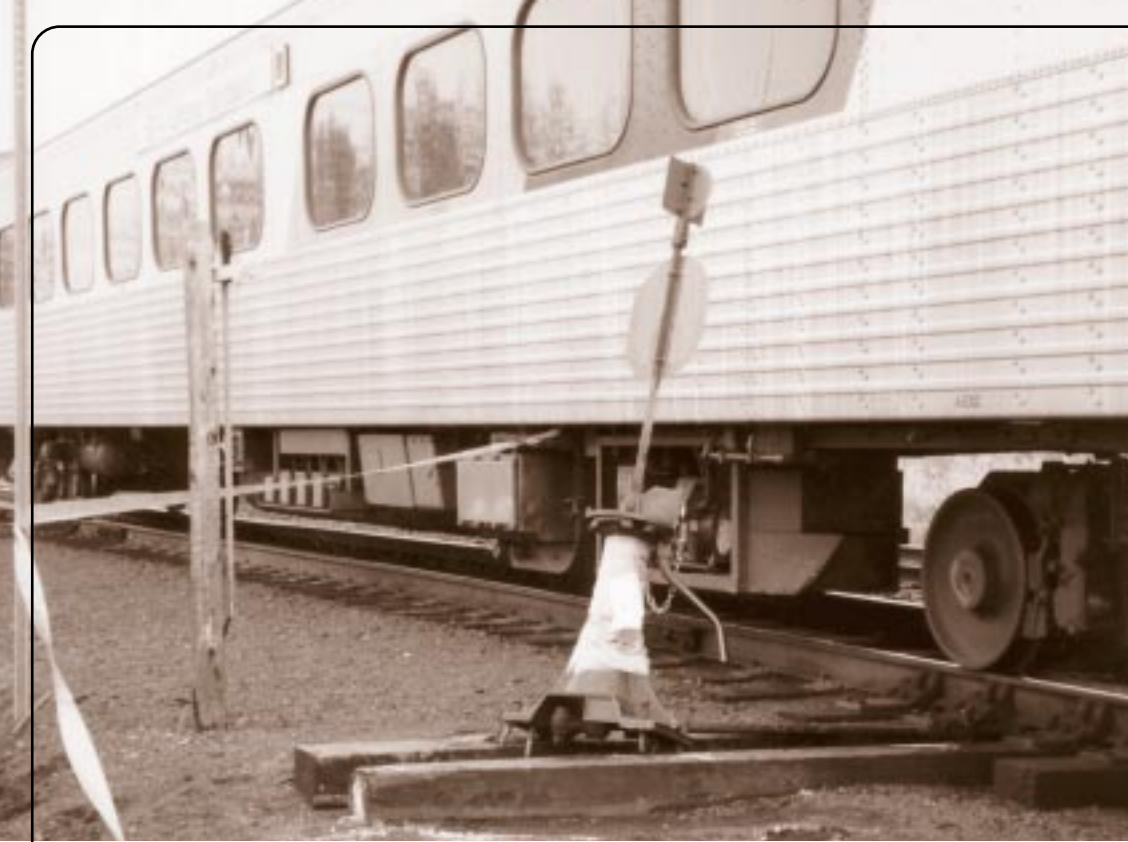
The switch stand for the siding at Mile 225.8 had been struck by an unidentified vehicle. The collision uprooted the stand and dislodged the anchoring ties.

The switch was canted over at 20 degrees from vertical. Tire tracks from the gravel road and white paint scuff marks on the switch stand, approximately 14 inches (about 36 cm) from the base of the stand, were evident. The switch stand securing spikes were loose, and the anchoring ties were dislodged. The switch was lined for the normal position, and the switch target was in place and properly indicated that the switch was lined for the main track. The components were in good condition, properly adjusted, and well maintained. The force required to dislodge the switch stand would have been considerable, and the person(s) responsible should have been aware of the impact.

TC verified that ONR had completed the actions required to address the Board's recommendations and outlined that TC will continue to monitor the ONR for compliance with passenger train safety requirements. TC also indicated that a switch point lock has been installed to prevent a similar occurrence at this location.

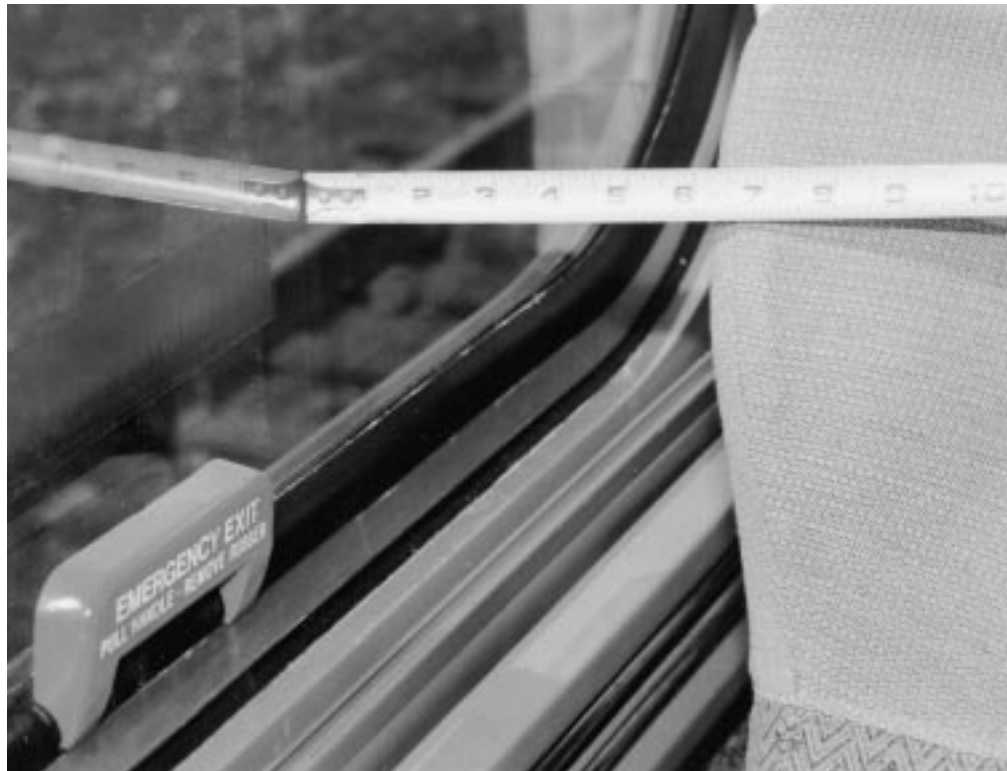
The proximity of the seat back hampered the removal of the emergency exit windows, which are designed to swing inward as though hinged at the top.

- The emergency windows were not subject to scheduled removal; if in place for a very long time, the seals become stiffer.
- Structural deformation of the coach would make the emergency window removal more difficult.
- The force required to remove the emergency window gasket varied considerably and in some cases was beyond the capabilities of passengers of average strength.
- The little metal handle on the emergency exit windows limits the force that can be applied to it and causes the windows to jam on the window frame.
- The weight of the window makes it difficult to manoeuvre.
- The lack of instructional signs on the exterior of the coach doors could hinder rescue efforts.

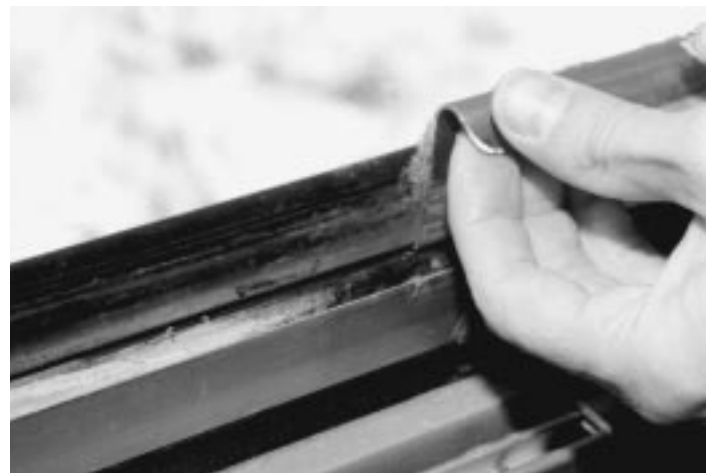
The size of the little metal handle on the emergency exit windows limits the force that can be applied to it. The handle also causes the windows to jam on the window frame.

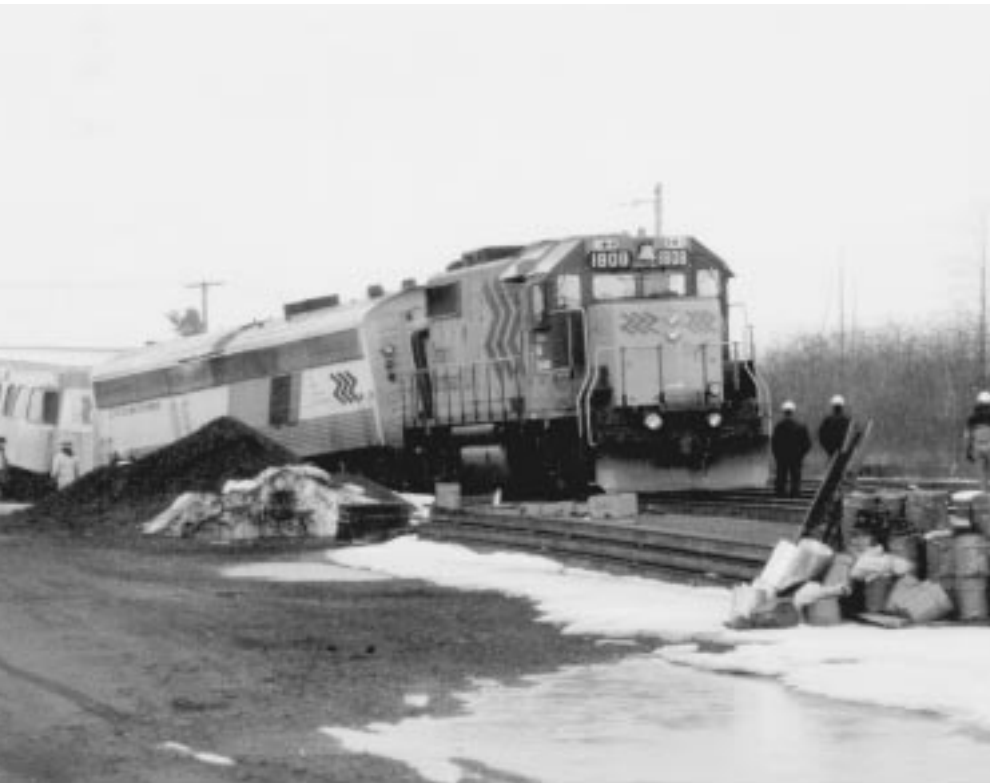
The damaged switch caused the locomotive, the electrical power unit, and three of the four coaches to derail.

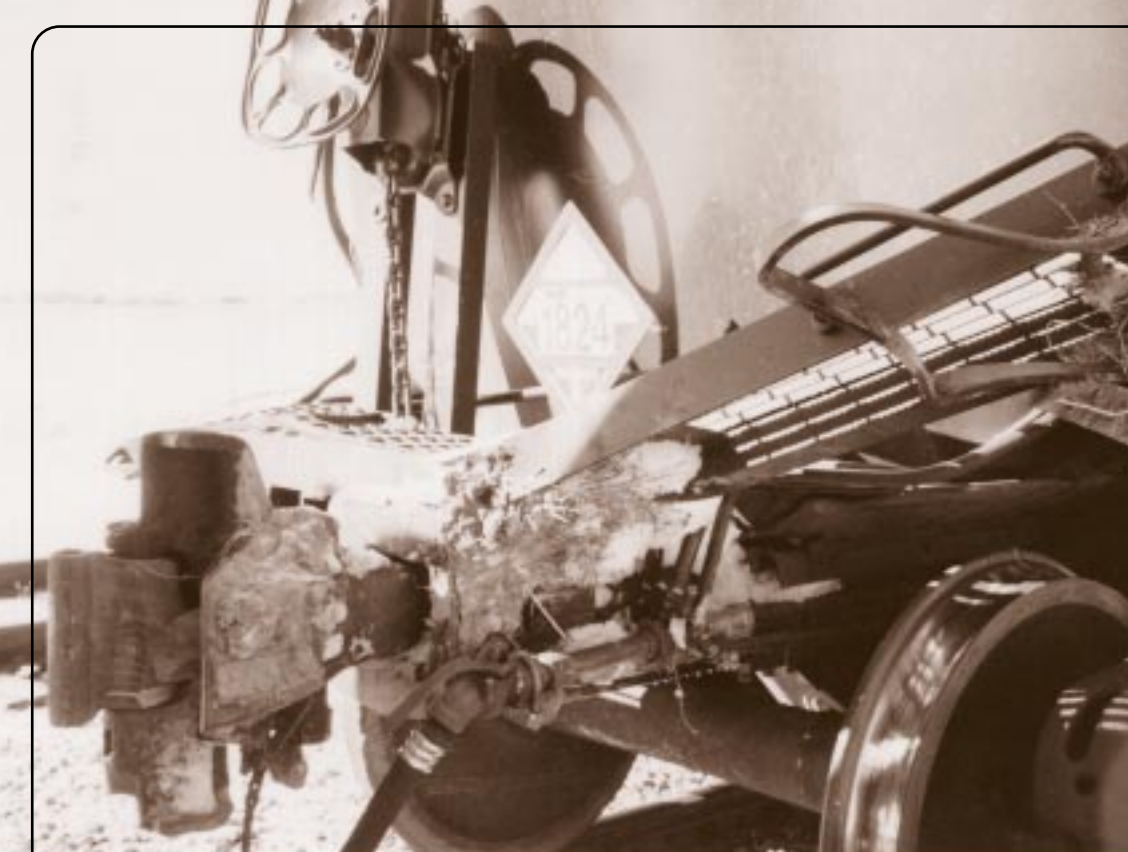
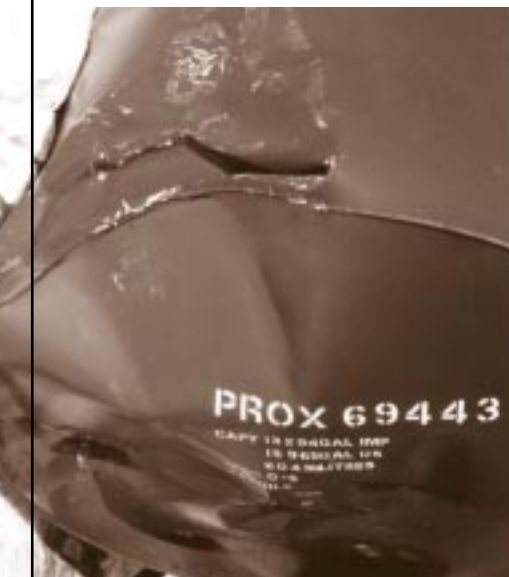
The collision knocked two tank cars containing a residue of caustic soda on their sides. Seven other tank cars containing a residue of caustic soda and two containing a residue of chlorine derailed but remained upright.

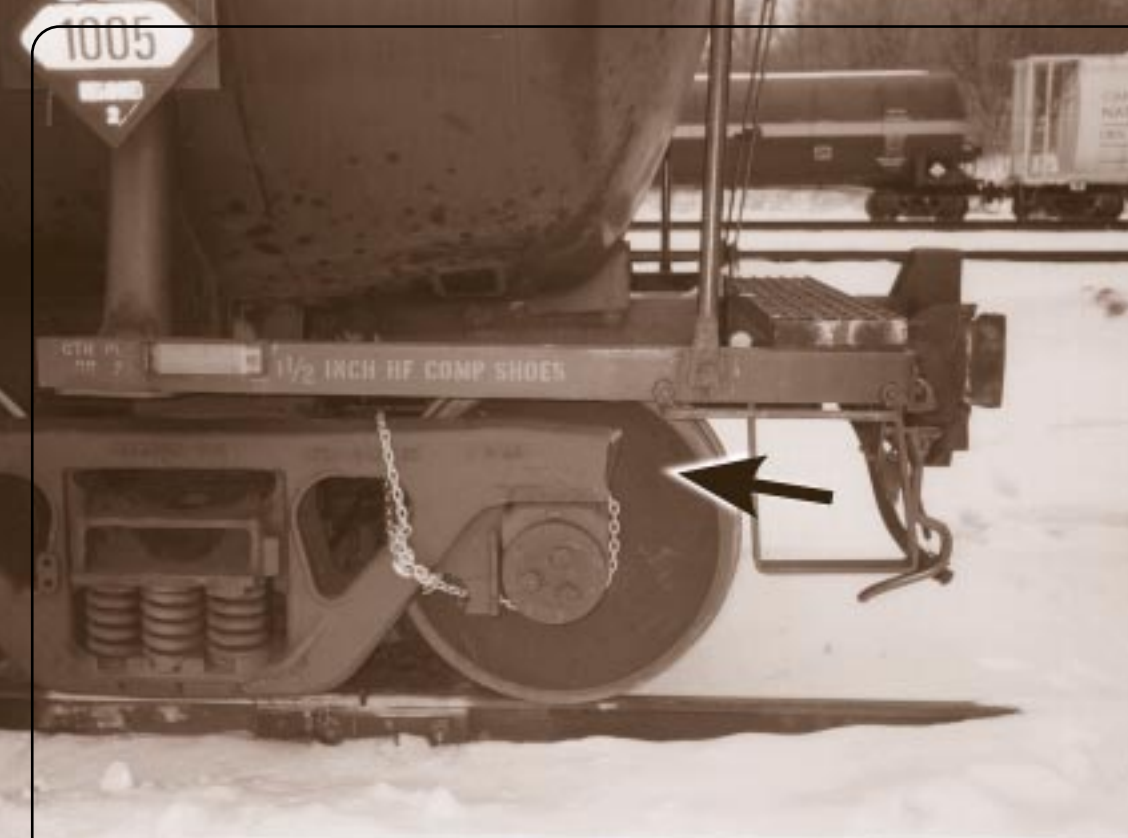
The subject side frame with the outer pedestal leg missing (arrow), as found by the investigator.

- The truck side frame failed as a result of overstress.
- The overstress resulted in brittle fracture of the truck side frame casting.
- The overstress initiated in the radius between the pedestal roof and the outer pedestal jaw.
- Factors likely contributing to the overstress initiation include the presence of casting defects, the proximity to the transverse weld of the roof liner, and the substandard fracture toughness of the truck side frame material.
- Material deficiencies and repair methods were observed that may have contributed to the failure.

Procor Limited revised its methods and modified the weld configuration of the wear liner. It has also initiated a program to inspect the transverse welds when the trucks are dismantled.

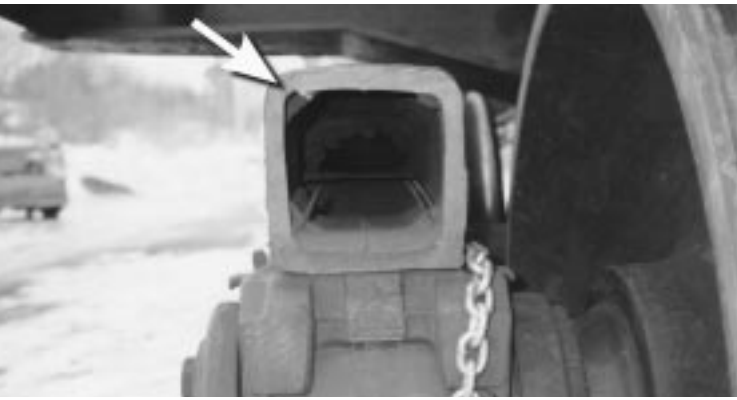
The fracture surface as found. The small shiny areas (arrow) and the light orange colour indicate that the fracture is relatively fresh.

Between 15 and 22 January 1997, the car was operated while loaded in very cold temperatures. Considering the brittleness of the truck side frame steel in low temperatures, it is believed that the truck side frame failed during this time. The nature of the fracture surface indicated that the outer pedestal jaw was not completely severed in the first fracture episode and may have remained attached for some time.

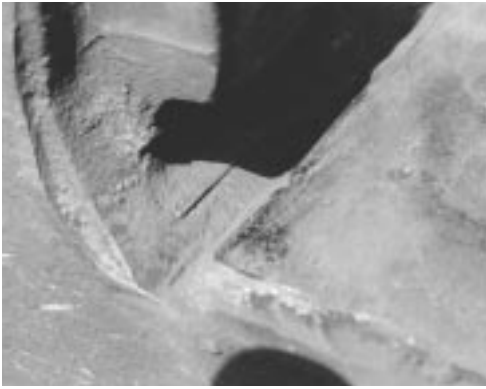
A casting defect observed in the radius between the pedestal roof and the outer pedestal jaw.

The failed truck side frame would have met the AAR specification for casting defects since the current specifications do not require the area in question to be inspected. It was determined that a casting defect had served as the initiation point of the crack that propagated through the truck side frame. Consequently, a review of the casting defect inspection criteria may be in order.

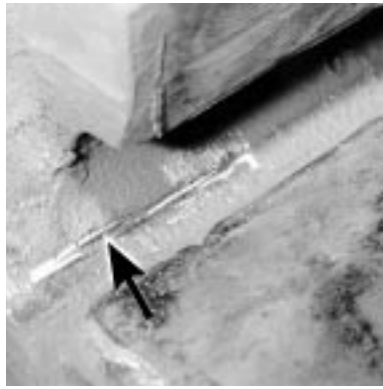
The casting defect after some exploratory work with a die grinder exposing a possible crack (arrow).

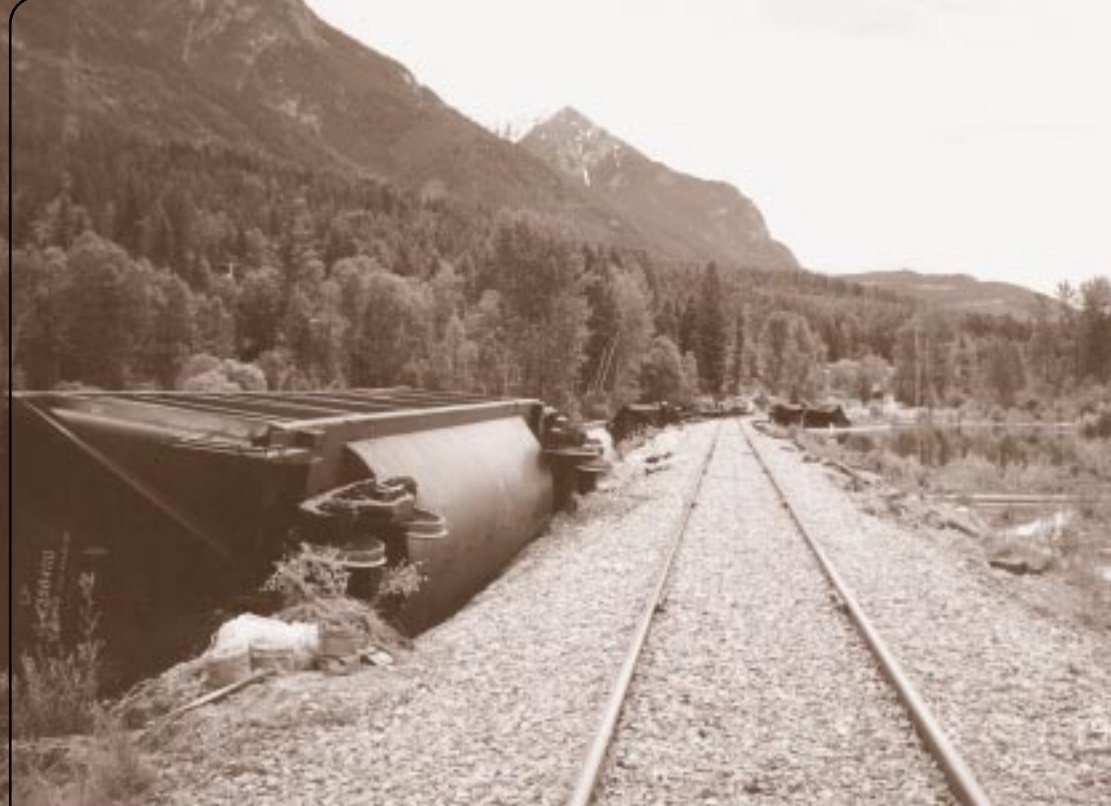
The subgrade was soft, with water standing on both sides of the track. The derailment occurred on a section of continuous welded rail with newly installed ties. The jointed rail shown in the photo is a component of the track panels, laid subsequent to the derailment.

- The ballast section was less than standard for CWR.
- The ballast was in poor condition and fouled with fine materials.
- The ballast was loose, and newly installed ties were not tamped.
- The ties were installed in clusters.
- The subgrade was soft.
- weakened track conditions,
- high compressive rail forces, or
- train vehicle forces.

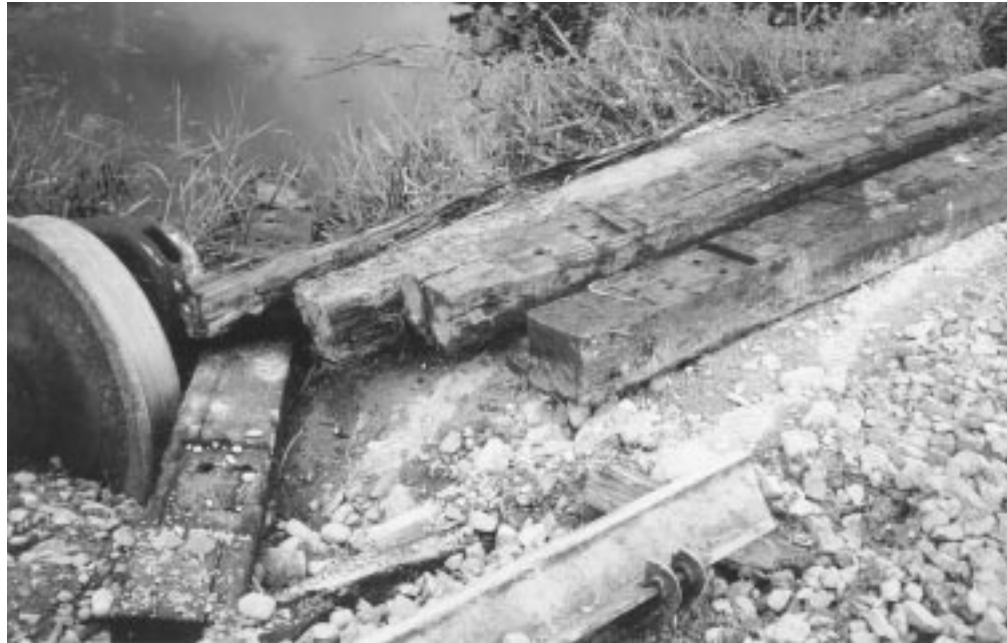
Broken ties, a broken rail, and part of a wheel set lie on the shoulder of the track.

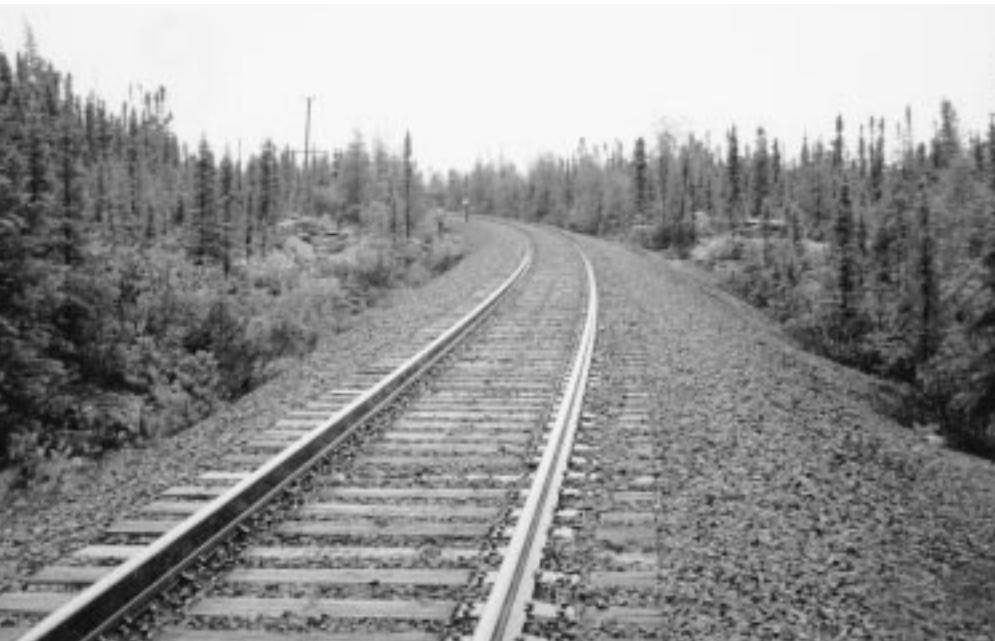
Approaching the point of impact from the north, there is a three-degree curve to the left and a slight ascending grade of 0.2 per cent. Sight lines were limited by forest and track curvature.
